# Manhole Inspection Summary

Manhole # S43E\_\_060MH

Insp Date: **6/10/08 10:57 AM**

**Location** Address: **rear 25 s broadway**

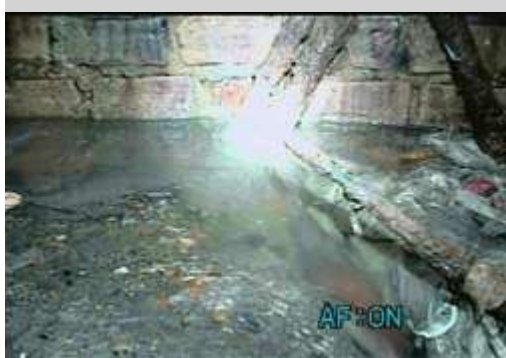
Defect 6

Condition: ☐ Sound ☐ Cracked ☐ Root Intrusion ☐ Deteriorated ☐ Leaks ☒ **Debris**

channel debris

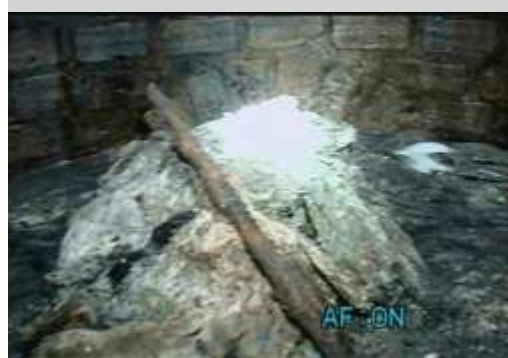
Defect 5

Condition: ☐ Sound ☐ Cracked ☐ Root Intrusion ☐ Deteriorated ☐ Leaks ☒ **Debris**

bench debris

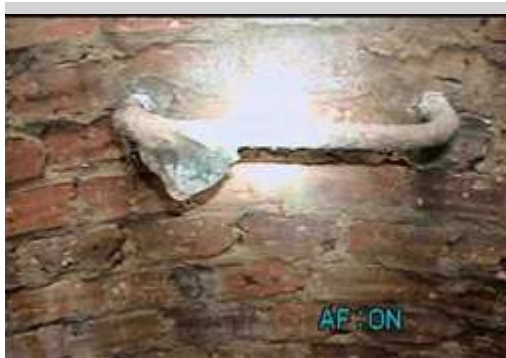
Defect 4

**Surcharge** ☒ **Evidence Of Surcharge** Depth: **4.8** (ft.) ☐ Active Surcharge Present

surcharge

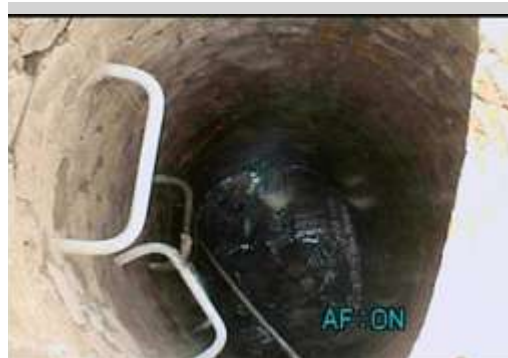
Defect 3

**Steps** Count: **7** Missing: **0** ☒ **Corroded**

steps

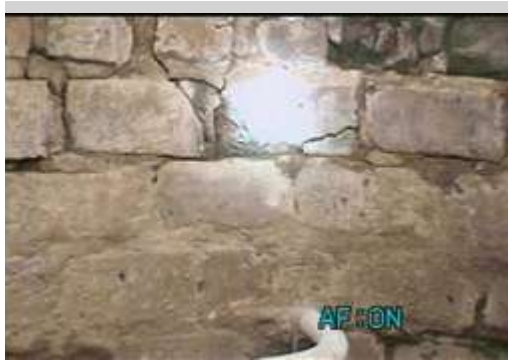
Defect 2

Condition: ☐ Sound ☒ **Cracked** ☐ Root Intrusion ☐ Loose Brick ☐ Deteriorated

Corbel cracked

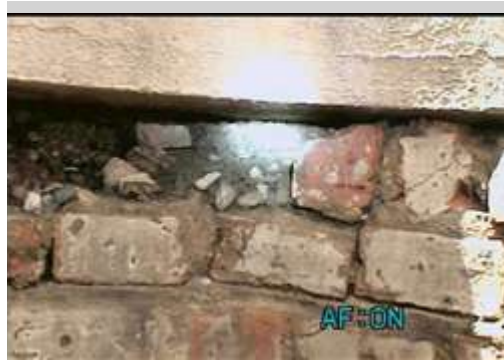
Defect 1

Condition: ☐ Sound ☐ Cracked ☐ Root Intrusion ☐ Loose Brick ☒ **Deteriorated**

Chimney deteriorated

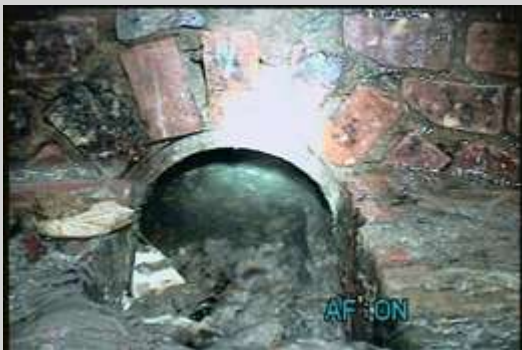
12 O'Clock Outflow

Pipe Height: **0** (in.) Direct  
Pipe Material: **Clay** ☐ Pipe Lined  
Invert Depth: **11.88** (ft.) Flow Characteristics: **Slow**  
Deposits: ☐ None ☐ Mud ☐ Sludge ☒ **Debris** ☐ Grease  
Silt Depth: **0** (in.) Deposits Extent:  
Infiltration: **None** Pipe Seal Cond: **Unknown**

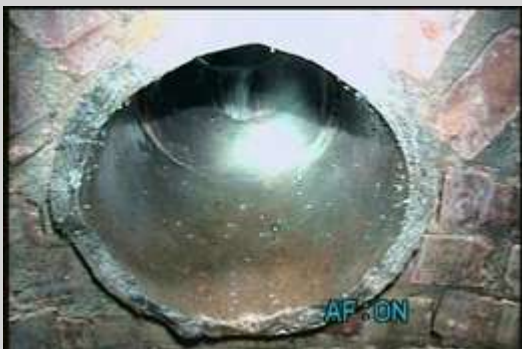
6 O'Clock Inflow

Pipe Height: **0** (in.) Direct  
Pipe Material: **Clay** ☐ Pipe Lined  
Invert Depth: **10.38** (ft.) Flow Characteristics: **Slow**  
Deposits: ☐ None ☐ Mud ☐ Sludge ☒ **Debris** ☐ Grease  
Silt Depth: **0** (in.) Deposits Extent:  
Infiltration: **None** Pipe Seal Cond: **Unknown**

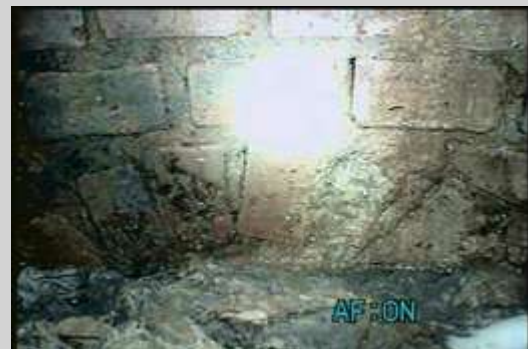
Drop In @ 6 O'Clock

6 is filled with debris

Drop: **Outside Direct**

Drop Condition: **Open**
